ASSISTANCE OF BIPORE TECHNOLOGY AS A RAINWATER INFILTRATION METHOD TO REDUCE SURFACE RUNOFF AND FLOODING

Abstract: The community service program (PPM) was implemented in RT.10, Sungai Duren Village, Muaro Jambi Regency, an area highly vulnerable to flooding due to its dense population and limited rainwater infiltration. The extensive presence of permanent buildings prevents effective water absorption, often leading to waterlogging and floods during heavy rainfall. This program aims to provide mentoring and outreach on flood mitigation by applying environmental conservation principles and promoting the construction of biopore infiltration holes. Additionally, it sought to analyze the causes of flooding based on spatial characteristics and community behavior. The service team comprised five multidisciplinary lecturers from Jambi University (UNJA) and five students. The participatory methods employed included Focus Group Discussion (FGD) and Participatory Rural Appraisal (PRA), designed to engage local communities in disaster mitigation planning. Monitoring and evaluation involved direct observation, interviews, and Google Form surveys to assess knowledge, awareness, and attitude cha

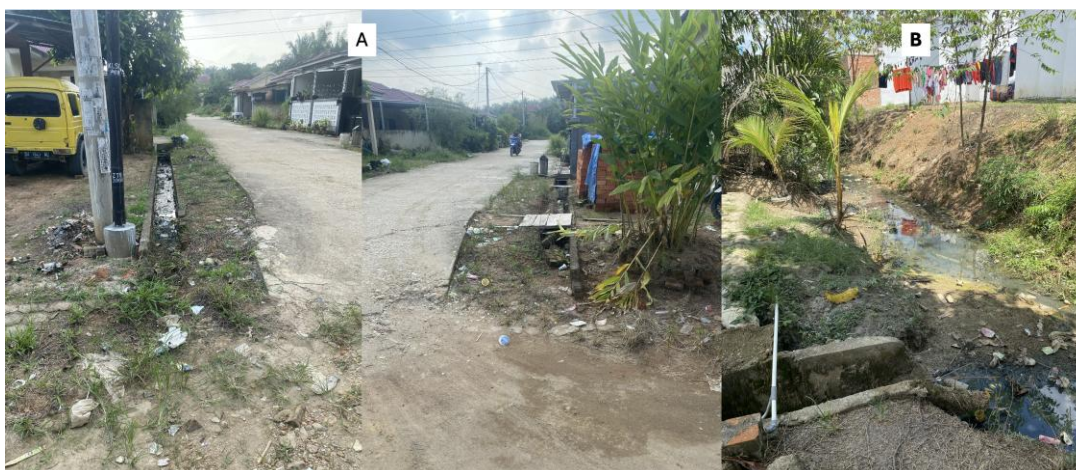
Figure 3. A. Disconnected household drainage system that flows onto the ground and concrete-paved road; **B.** Artificial canal functioning as the main wastewater drainage channel, but has become silted

The drainage systems in the residential area are not interconnected, causing some household wastewater to flow directly onto the concrete-paved ground and streets. Additionally, although a canal in the PPM partner area functions as the main drainage channel, it has become silted due to a buildup of sediment and household waste carried in during floods. Sediment accumulation and debris blockages in drainage networks are well-documented factors that significantly reduce the hydraulic capacity of urban water channels, thereby undermining flood prevention measures (Shuster et al., 2005; Ferrans et al., 2022).

rates. When rainfall intensity exceeds the drainage system's capacity, excess water quickly accumulates, leading to flash flooding. In Muaro Jambi and other similar low-lying areas in Indonesia, this issue is exacerbated by high seasonal rainfall, poor urban planning, and inadequate waste management (Handayani et al., 2020). The drainage systems and artificial canal can be seen in Figure 3.

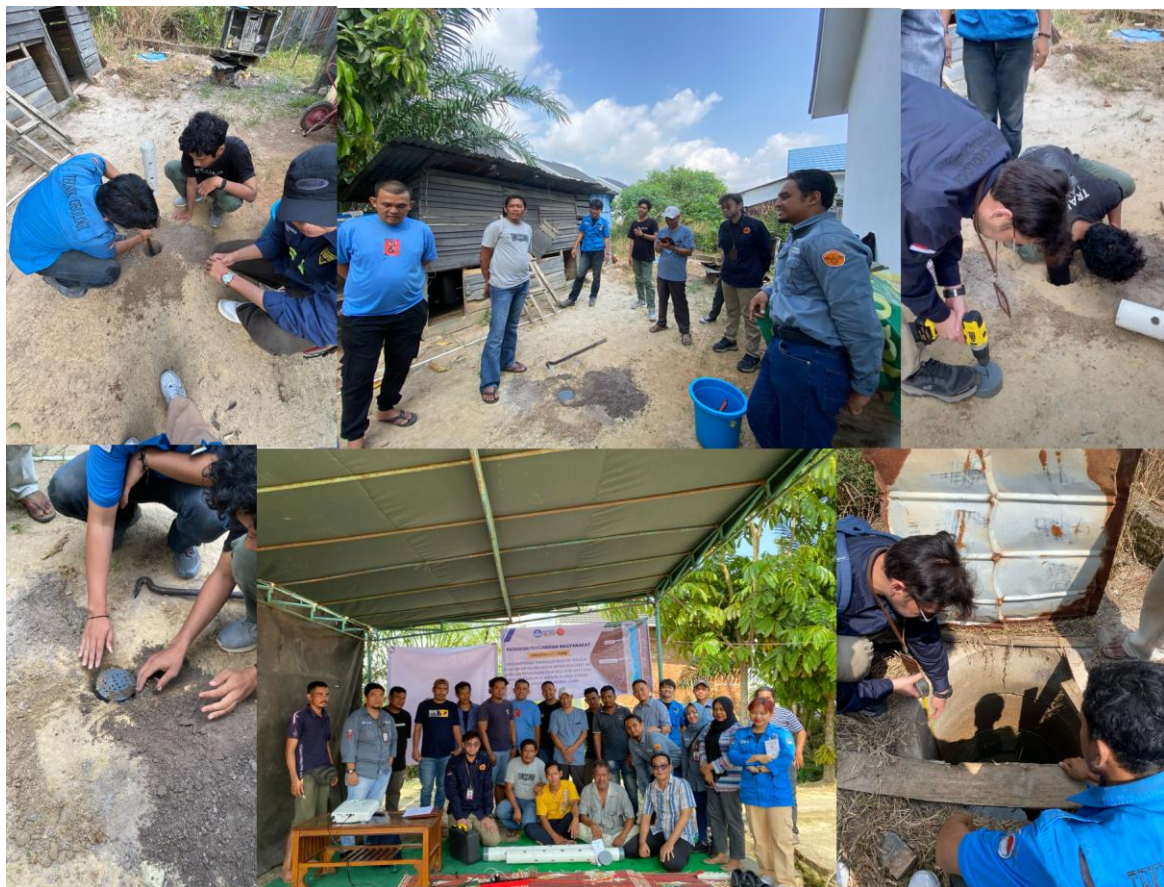
Figure 6. The second session of the assistance activity for creating biopore infiltration holes and measuring the groundwater table at the dug well conducted in the yard of the RT.10 Head's house in Sungai Duren Village, Muaro Jambi Regency

The second session, still related to environmental conservation principles, was the awareness session on creating biopore infiltration holes, applied in the yard of the RT.10 Head's house in Sungai Duren Village, Muaro Jambi Regency. The biopore technology awareness aimed to address environmental issues caused by surface water runoff, flooding, and household organic waste. The presentation on biopore technology was delivered by Bagus Adhitya, S.T., M.T., a lecturer from the Geological Engineering program and the Head of the PPM Team from the Department of Earth Engineering, University of Jambi. After the awareness session and discussion, the assistance activities for creating biopore infiltration holes were conducted, guided by the team of lecturers and students from the Department of Earth Engineering. The biopore technology assistance activities of the PPM can be seen in Figure 6.

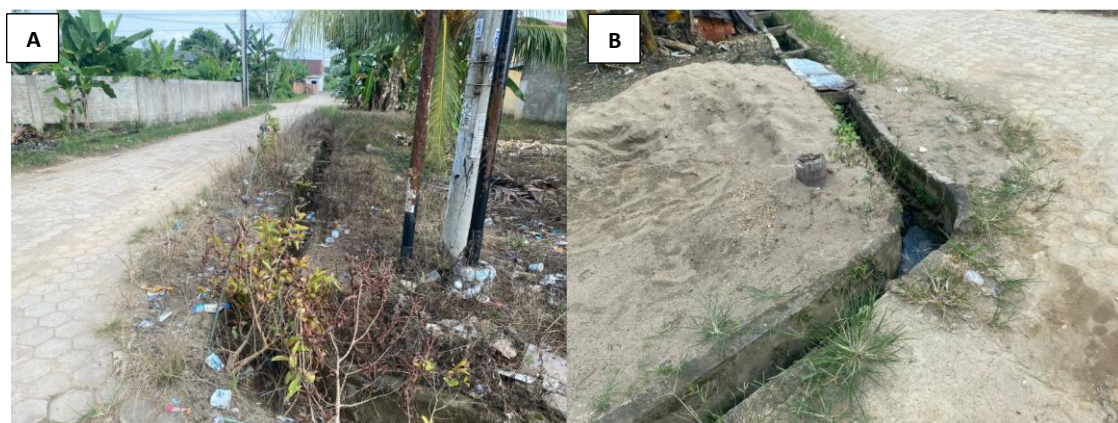
Figure 8. Changes in community attitudes toward the importance of environmental cleanliness. Image A shows the condition before the socialization on July 20, 2024, and Image B shows the condition during monitoring and evaluation on September 9, 2024

Based on direct observations made on September 9, 2024, approximately 50 days after the socialization activities were conducted, the overall cleanliness level of the environment has started to improve. The PPM partner has undertaken community service activities; however, due to heavy rainfall, a significant amount of plastic waste has been washed back into the area. Fortunately, this litter is only present in a few spots, and overall, the partner area has become much cleaner. This situation can be managed by maintaining cleanliness in each household's surroundings, rather than waiting for community cleanup efforts. An illustration of the change in community attitudes toward environmental cleanliness can be seen in [Figure 8](#).

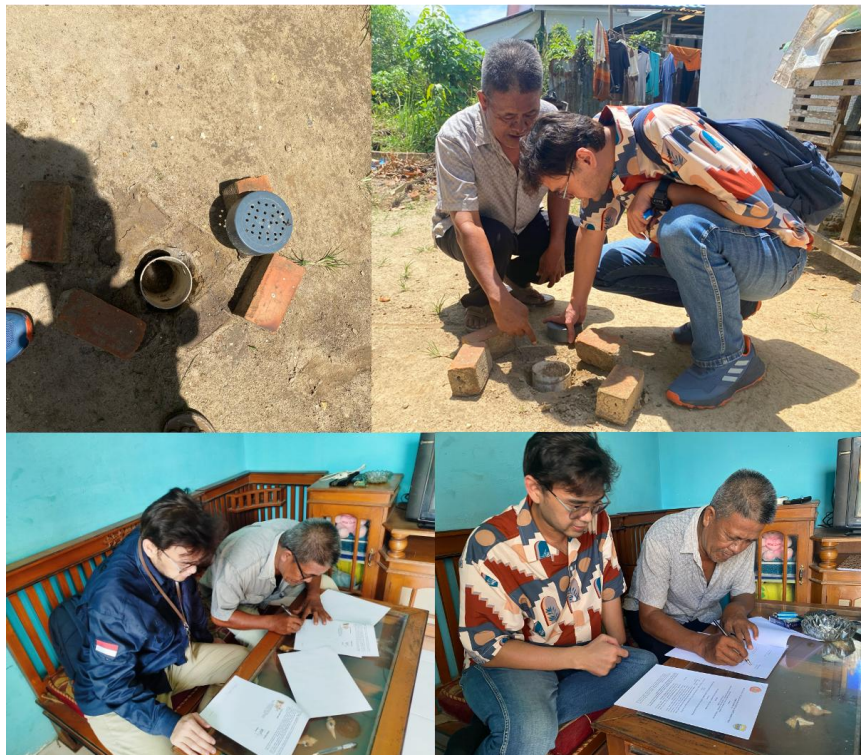
Figure 9. Monitoring and evaluation of biopore infiltration hole performance and signing of the implementation arrangement

correctly and being properly maintained. Discussions with the RT.10 Head of Sungai Duren Village indicate that the infiltration holes are performing well in reducing surface water flow. Organic waste is routinely added to the biopore holes to support the survival of macro and microorganisms within the holes, thereby increasing the number of pores formed in the soil.
